# **Community flood plan**

**Severn Grove, Romilly Crescent and  
Conway Road, Cardiff, Wales**

## **REPORT ON STREET TREES- REQUEST FOR ACTION**

Severn Grove, Romilly Crescent and Conway Road Community Flood Plan Group

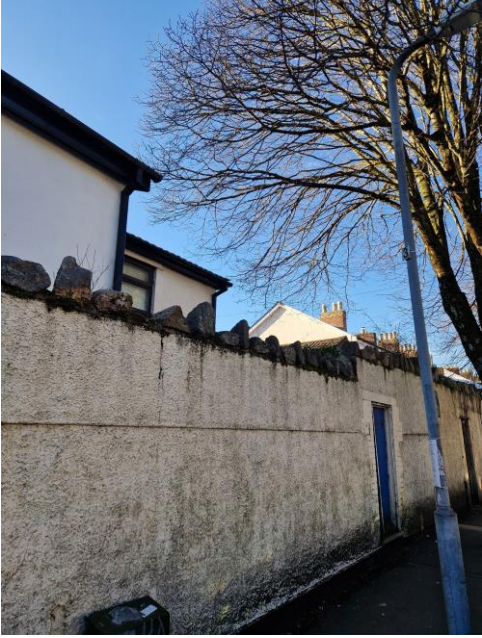
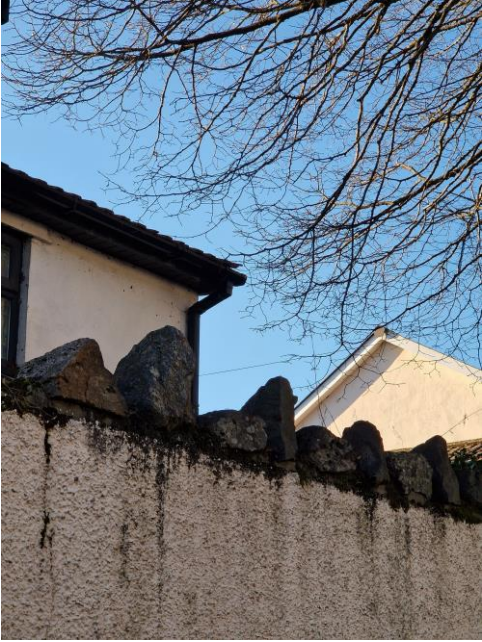
Near house no.	Photos
SEVERN GROVE	
West side	
1

Severn Grove- near house no.	Issue	Requested action	Priority
<b>West side</b>	All street trees below overhang front gardens		
1	Touching the front elevation	Cut back nearest and lower branches to nearest main branch or trunk.	Yes
5	300mm from front elevation	Cut back nearest and lower branches to nearest main branch or trunk. Tidy up other cuts back to main branches/trunk to restore natural shape.	
37	250mm from front elevation. Low dense crown over garden.	Cut back nearest and lower branches to nearest main branch or trunk to raise crown above garden.	Yes
41/43	400mm from front elevation	Cut back the few nearest branches to nearest main branch or trunk.	
57	(Outside Hafren Court) 100mm from front elevation	Cut back a few nearest branches to nearest main branch or trunk.	
67	(Outside Stoneleigh Court) Touching the front elevation	Cut back the few nearest and lower branches to nearest main branch or trunk.	Yes

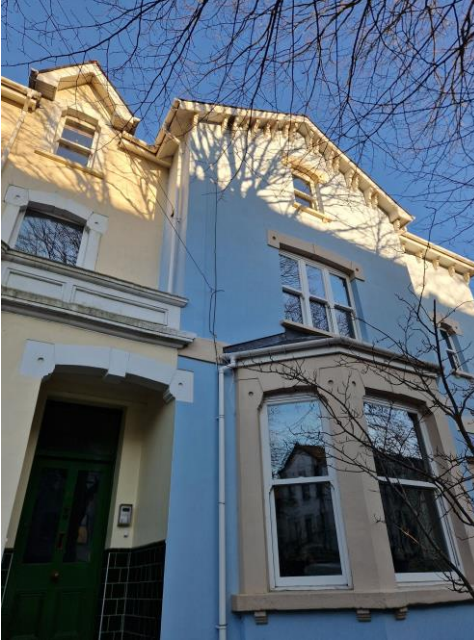
Near house no.	Photos
<b>CONWAY ROAD</b>	
16

Conway Road- near house no.	Issue	Action	Priority
		trunk.	
29	100mm from front elevation at high level	Trim back the nearest branches to nearest main branch.	
45	300mm from front elevation with dense crown at high level	Cut back the nearest branches and thin to nearest main branch.	
61	500mm from front elevation but low crown over garden.	Cut back nearest and lower branches to nearest main branch or trunk to raise crown above garden.	
<b>East side</b>			
4	200mm from front elevation at high level	Trim back the nearest branches to nearest main branch.	
16	(Outside Flats 1,2,3) Touching the front elevation at high level	Cut back the few nearest and lower branches to nearest main branch or trunk.	Yes
48	100mm from front elevation at high level	Cut back the nearest branches to nearest main branch or trunk.	
68	200mm from front elevation at high level	Cut back the nearest branches to nearest main branch or trunk.
